DEPARTMENT OF NATURAL RESOURCES  
DIVISION OF OIL, GAS AND MINING

RE: Site Inspection, Clayton Stocks, Red Rock Mine, M/037/050, San Juan County, Utah

Date of Inspection: May 13, 1992

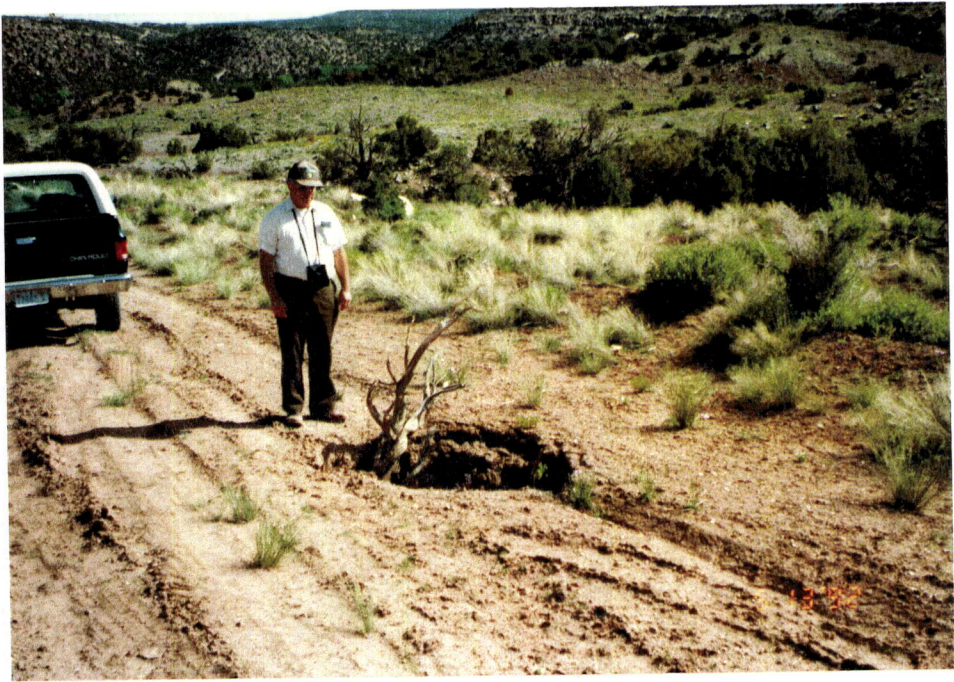
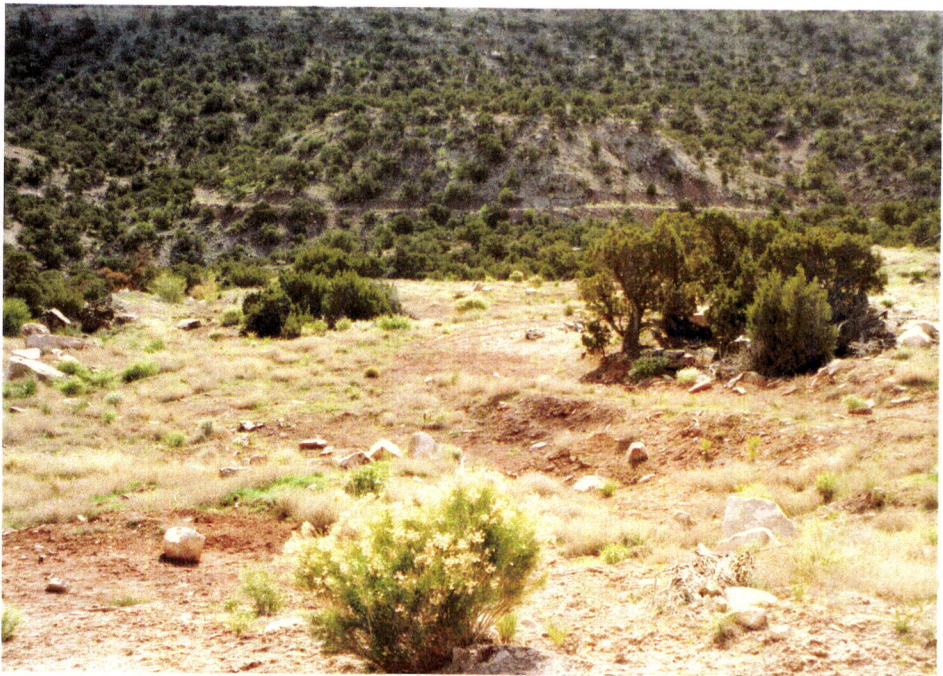
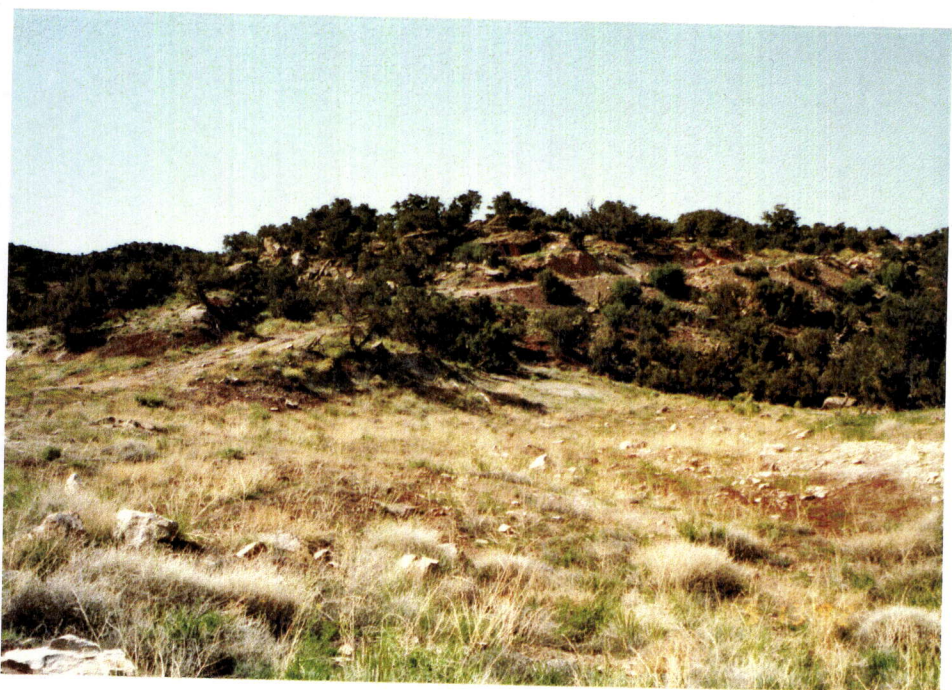
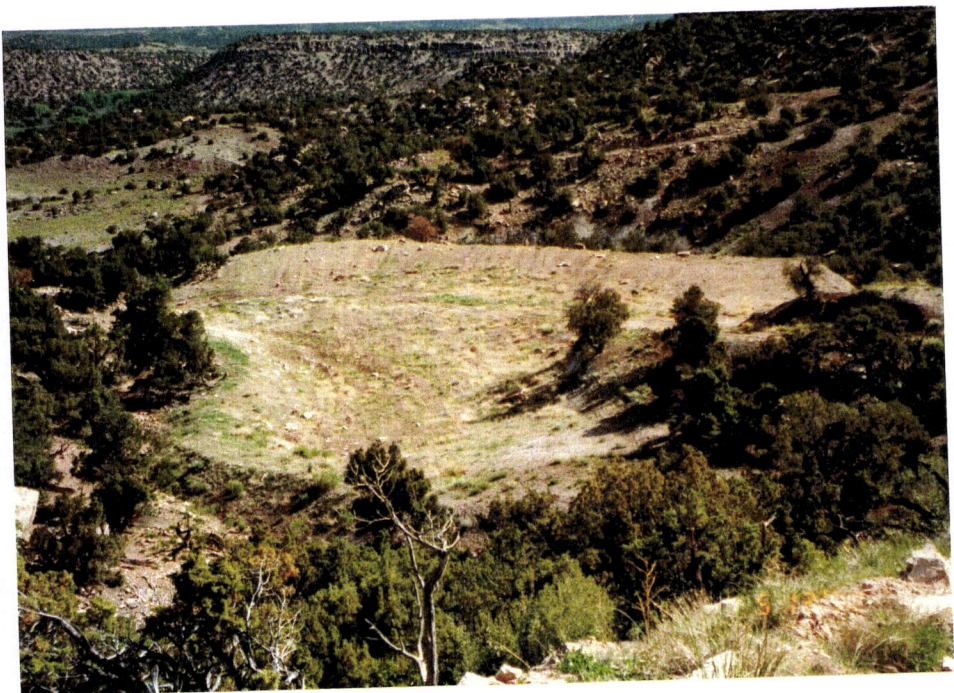
Mr. Venticinque and I agreed that the site can be released in its entirety after a couple of things have been fixed by the operator. One of those things is to repair a sink hole that appears in the mine access road and may have resulted from water connecting with underground workings or water finding an old drill hole. The sink hole is about 3 feet in diameter and about 4 feet deep at this time. Someone has thrown an old dead juniper tree in the hole to help plug it up. It appears that it will continue to expand and grow unless somehow it can be filled and repaired. Also, even though the operator established some large berms to prevent people from going onto the site, people have reestablished the roadway on the site that goes through the site and then up onto the higher areas above the mine site. We have asked Mr. Clayton Stocks to reestablish these berms to prevent further access onto the site and to ultimately help stabilize the site.

I recommend that the Division release Mr. Stocks from further reclamation obligations at the Red Rock and refund the operator's surety. Please see the attached photos taken during this last inspection.

I received a call from Mr. Sal Venticinque of the BLM, on May 18, 1992. He indicated to me that he and Mr. Stocks had visited the site and repaired the sink hole. He also indicated that Mr. Stocks had convinced him that repairing the road berms would be pointless because people would still drive around them. I agreed to leaving the road berms alone.
